THE EFFECT OF THERMAL-MECHANICAL PROCESSING  
ON THE EXFOLIATION CORROSION RESISTANCE  
OF AN ALUMINUM-ZINC-MAGNESIUM-COPPER ALLOY

THESIS

THE UNIVERSITY OF MISSOURI - ROLLA

MASTER OF SCIENCE IN METALLURGICAL ENGINEERING

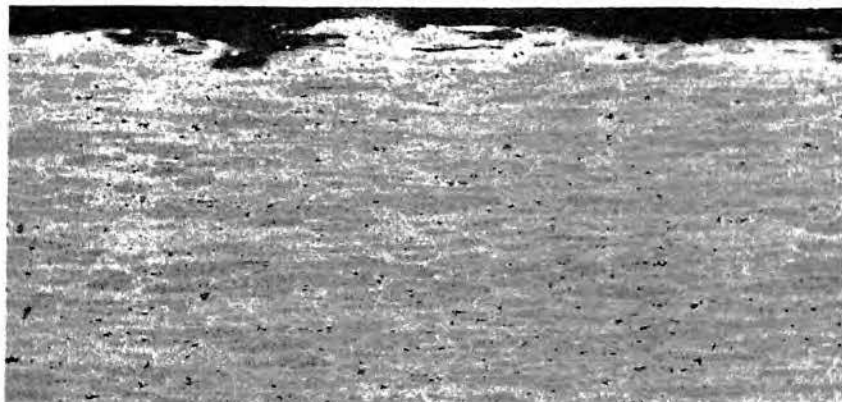
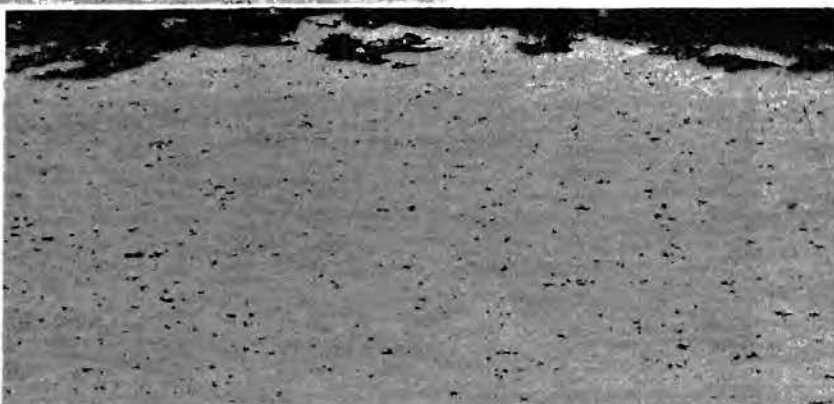
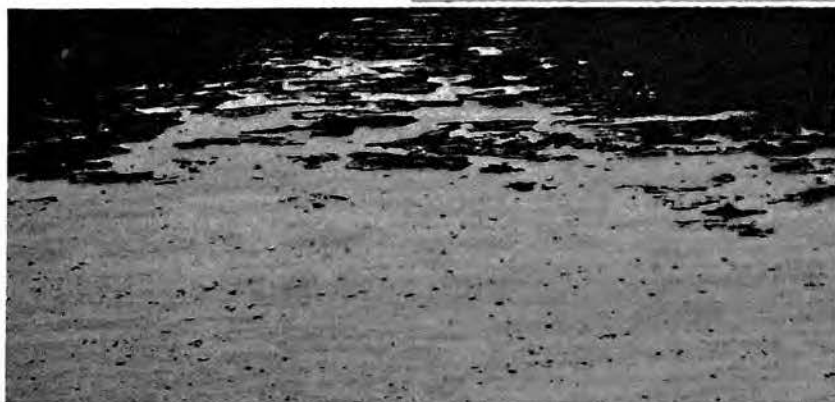
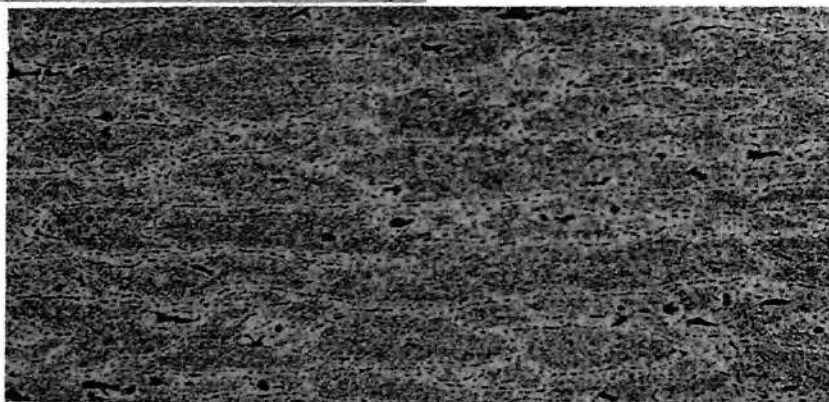
FIGURE 18 – Specimen A5 After Exposure to Both Exfoliation Corrosion Tests

Surface After Acidified Sodium  
Chloride Corrosion Test  
MAG. 75X

Surface After Sodium Chloride  
Plus Sulfur Dioxide Gas  
Corrosion Test  
MAG. 75X

Midplane After Sodium Chloride  
Plus Sulfur Dioxide Gas  
Corrosion Test  
MAG. 75X

Microstructure of Annealed  
0.390 Inch Thick Specimen  
MAG. 250X

The 0.390 inch thick annealed material exposed to the two exfoliation corrosion tests showed no exfoliation in the acidified salt spray test but did exhibit a minor amount of pitting at midplane. In the NaCl plus SO<sub>2</sub> environment a very minor amount of exfoliation was

evident at midplane. Metallographic examination of this specimen after exposure to both corrosion tests is shown in Figure 18.

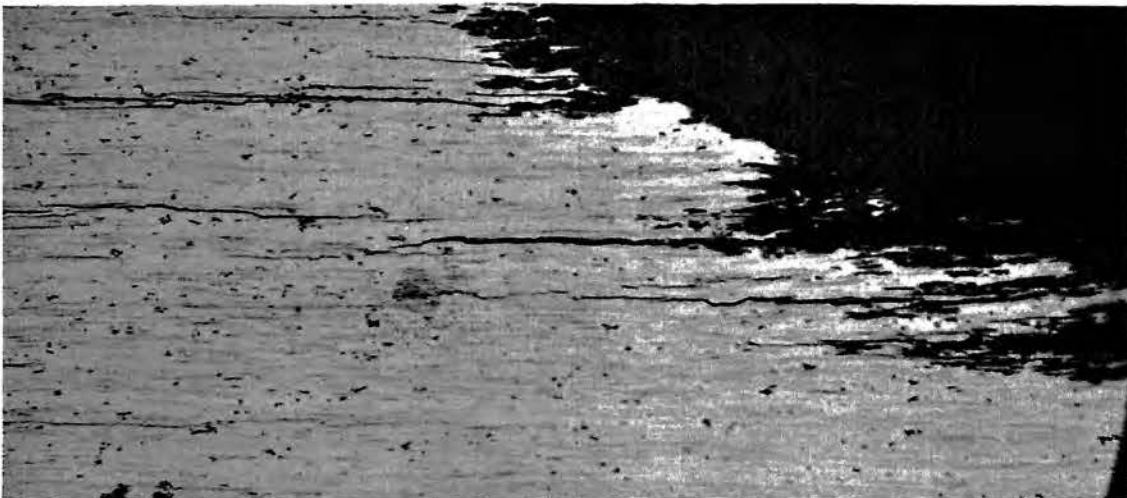
FIGURE 47 – Examples of Midplane Cracking

None – Specimen A4 – Acidified Sodium Chloride – MAG.75X

Moderate – Specimen W3X – Sodium Chloride Plus Sulfur Dioxide Gas – MAG. 75X

Very Severe – Specimen W3 – Sodium Chloride Plus Sulfur Dioxide Gas – MAG. 75X

In addition to pitting and surface and midplane exfoliation caused by both corrosive environments, some specimens exfoliated severely enough at midplane to be classified at "midplane cracking". A summary of the specimens which exhibited midplane cracking is presented in Table VI. All of the 0.390 inch thick material reduced in the solution heat treated condition, "cracked" in both the acidified salt and in the NaCl plus SO<sub>2</sub> gas environments. The cold reduced 0.250 inch thick material, reduced in the solution heat treated condition, showed only minor to moderate "midplane cracking" in the NaCl plus SO<sub>2</sub> gas tests. The "midplane cracking" is severe exfoliation attack at the radius of the specimens and demonstrates the reduction in structural integrity which can result from this type attack. Examples of the type of "midplane cracking" experienced are shown in Figure 47.

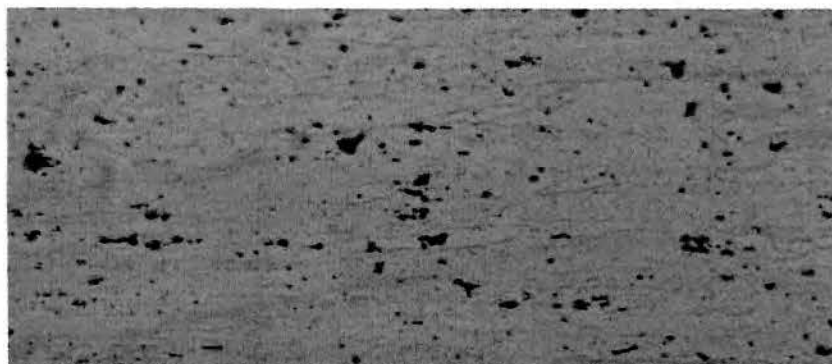
**FIGURE 51 – Microstructural Comparison of 0.250 Inch Thick Material  
Reduced in the Solution Heat Treated Condition**

Specimen W4X  
Control

Specimen W1X  
40% Reduction

The 0.250 inch thick material reduced in the solution heat treated condition and only aged after reduction exhibited very directional, highly worked grains which demonstrated progressively less resistance to exfoliation corrosion attack. These microstructures are shown in Figure 51.
